Polymer Materials for Ground Mobile Millimeter-Scale Robotics

ARL-TR-4659

December 2008

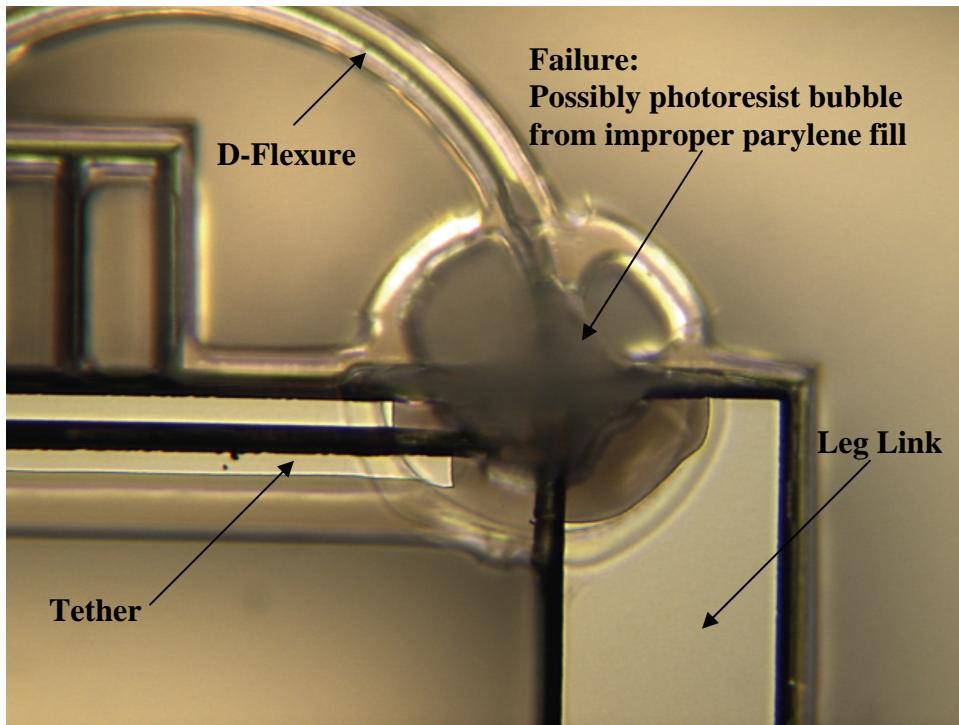
Observations of the first processed wafers indicate that over half of the structures exhibited defects at junctions where four trenches meet as seen in photographs from an optical microscope in figures 4 and 5.

Figure 4. This photograph from the optical microscope illustrates failure at the junction between the flexure and the leg link, possibly from improper parylene fill or photoresist bubbles.

The defects are of specific concern because these failures are occurring at connection points of the flexure, which are essential in providing a connection to the anchor, as well as creating torsional rigidity and in-plane flexibility. If this connection fails, then the leg link could be completely separated from the actuator or twist out of plane. Process or design changes are necessary to correct these issues. Options include depositing thicker parylene coatings to properly fill the junctions, decreasing the width of trenches near junctions, and avoiding four-trench junctions where possible.

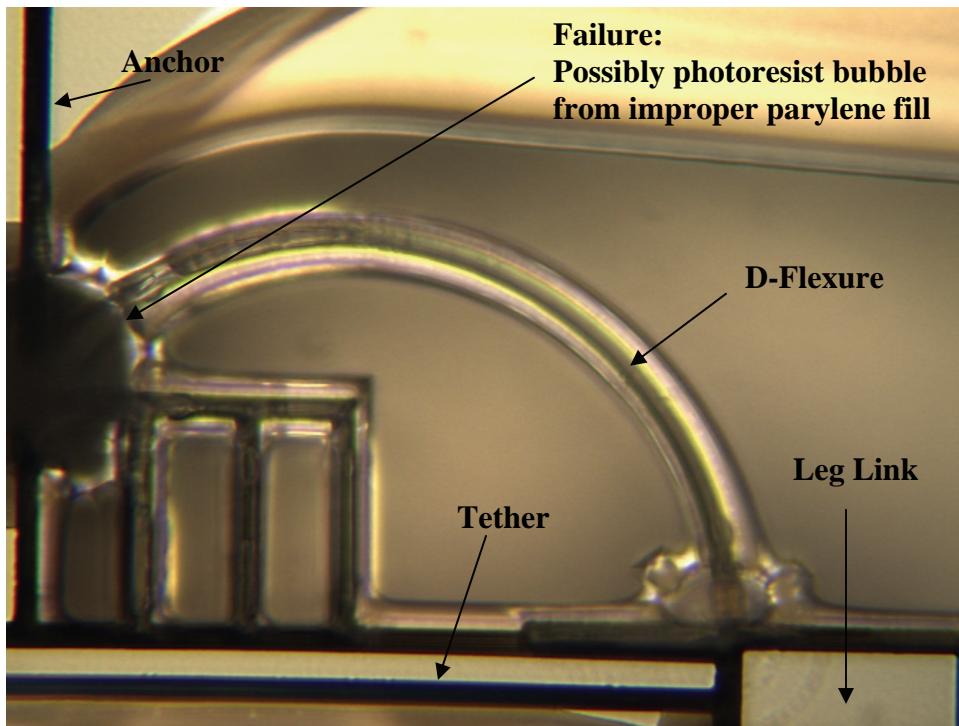
Figure 5. This photograph from the optical microscope illustrates a failure at the junction between the D-flexure and the anchor, possibly from improper parylene fill or photoresist bubbles.

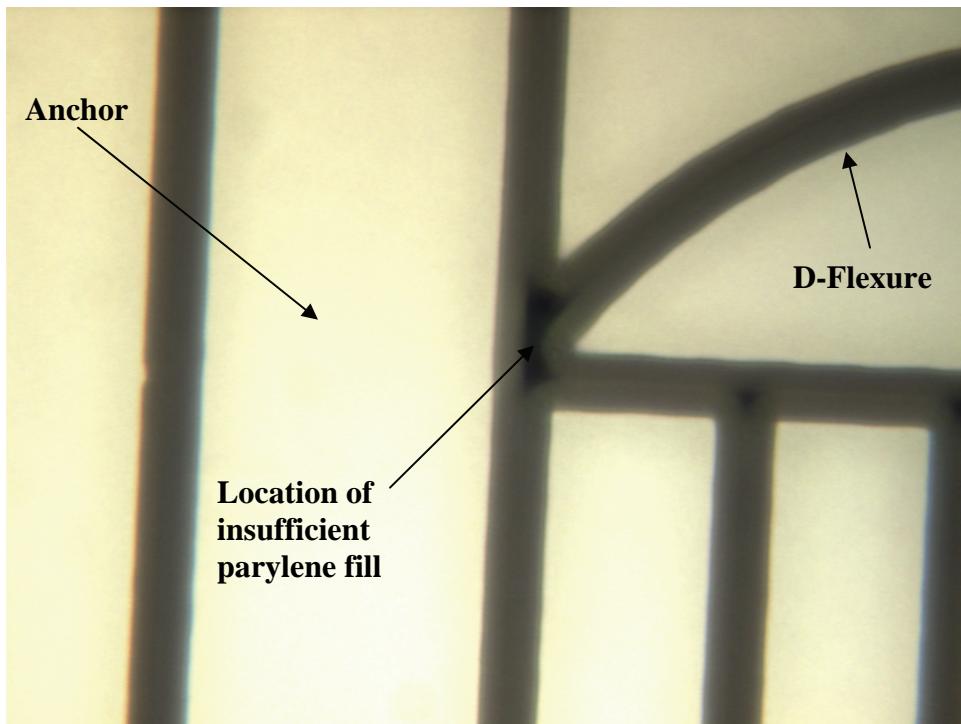
Insight into the failure at the four-trench junctions may be seen immediately after parylene coating in figures 6 and 7, showing that the parylene did not fully coat the entire junction. These images indicate that a thicker parylene coating should be deposited to properly fill the entire trench at the junction intersections or a mask change should be made to decrease the width of the trenches near the intersections.

Figure 6. This photograph from the optical microscope shows insufficient parylene fill in the dark black areas near the four-trench junction at the anchor and D-Flexure intersection.

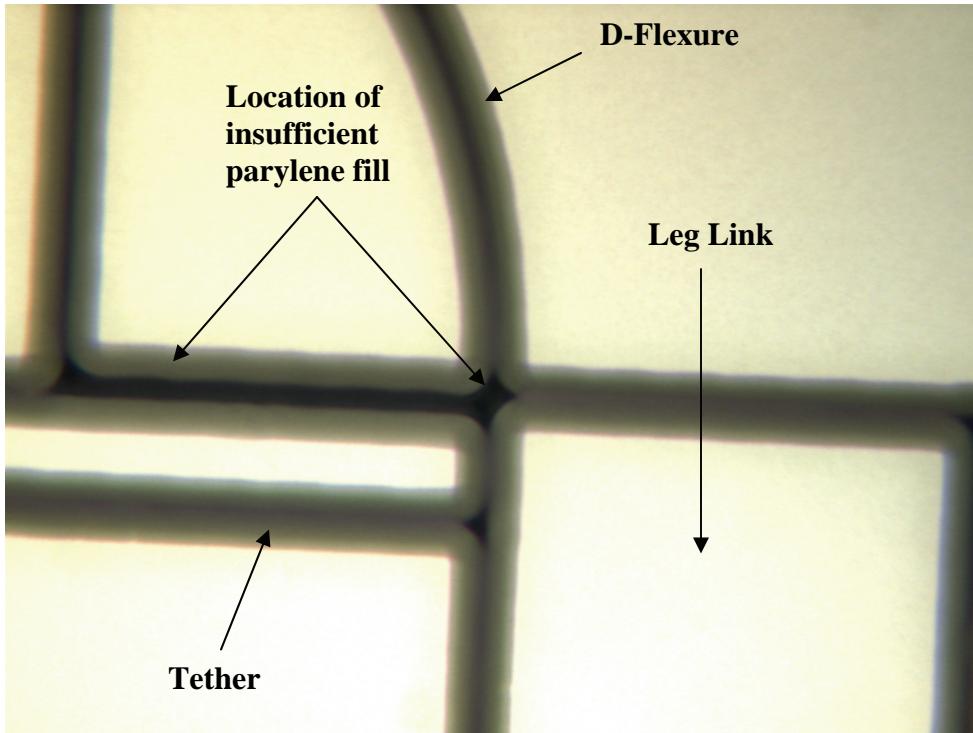
Figure 7. This photograph from the optical microscope shows insufficient parylene fill in the dark black areas near the D-Flexure-leg link four-trench junction.

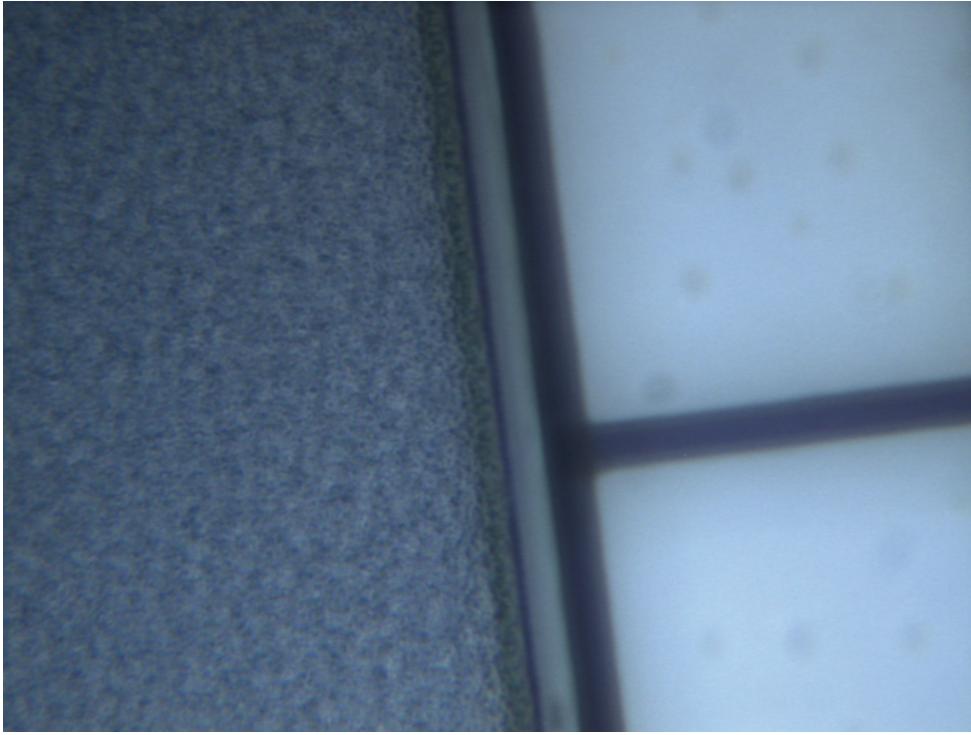
Parylene etching has presented a problem in this process because the original methods of using Axcellis Downstream Asher resulted in more than $9 \mu\text{m}$ of parylene undercut due to the isotropic nature of the etching process. This undercut is more than $3 \mu\text{m}$ larger than the tolerable undercut in the design. For this reason, the etching process was changed to use an anisotropic RIE in order to prevent this excessive undercut (3). Using a Lam 590 parallel plate RIE system, the process showed considerable improvement with less than a $2 \mu\text{m}$ undercut. However, the process leaves behind residues on the exposed silicon surface, as seen in figure 8.

Figure 8. Surface residue on exposed silicon after anisotropic oxygen plasma RIE Lam 590.

At this time, it is unknown whether or not this residue will pose a problem with the final process steps. Further analysis needs to be done to determine if this is a significant issue.
